# **INDOOR AIR QUALITY ASSESSMENT**

**Veterans Memorial High School  
485 Lowell Street  
Peabody, Massachusetts**

Prepared by:  
Massachusetts Department of Public Health  
Bureau of Environmental Health Assessment  
April, 2002

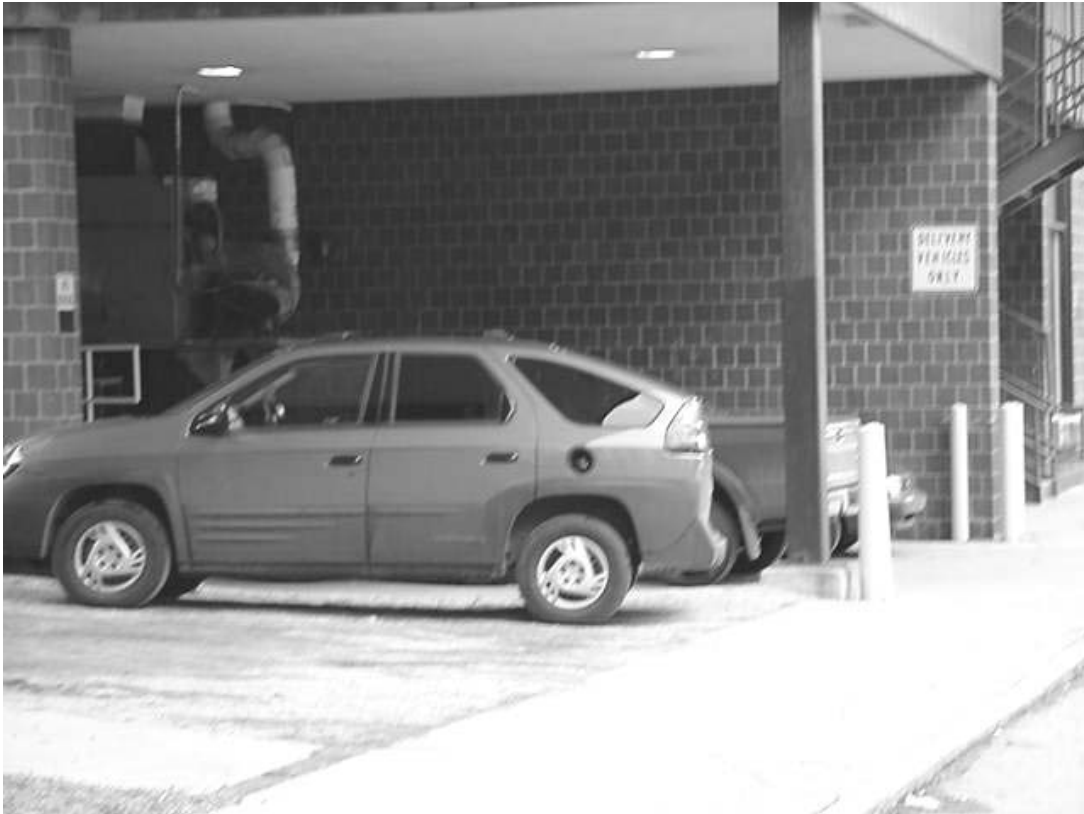
**Picture 26**

**Private Vehicles Parked Beneath Air Intake; Note Sign Reads “Delivery Vehicles Only”**

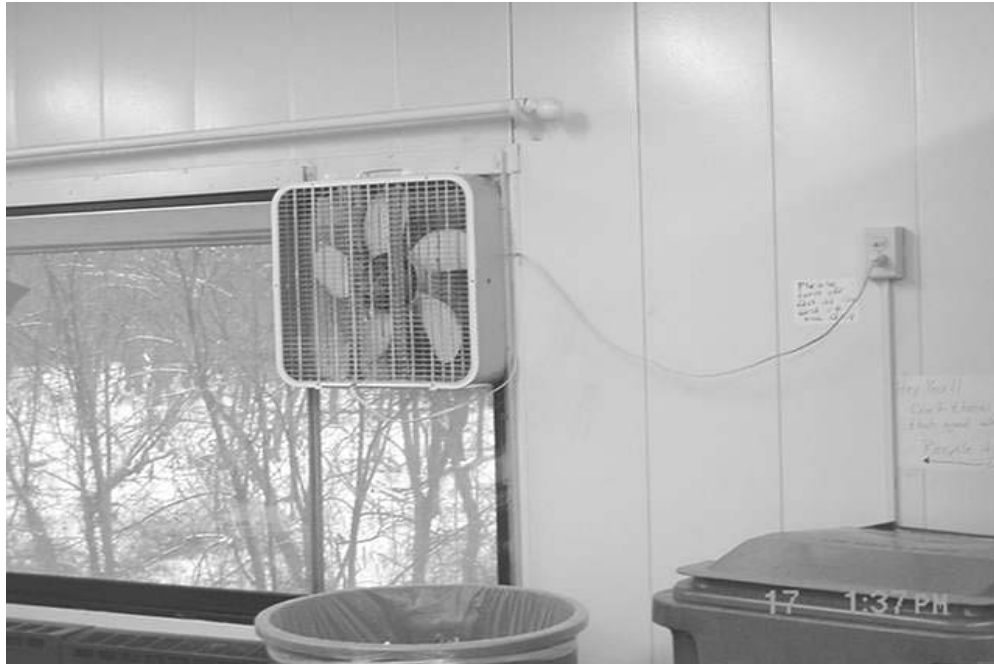
**Picture 27**

**Household Fan Mounted In Window for Exhaust Ventilation**

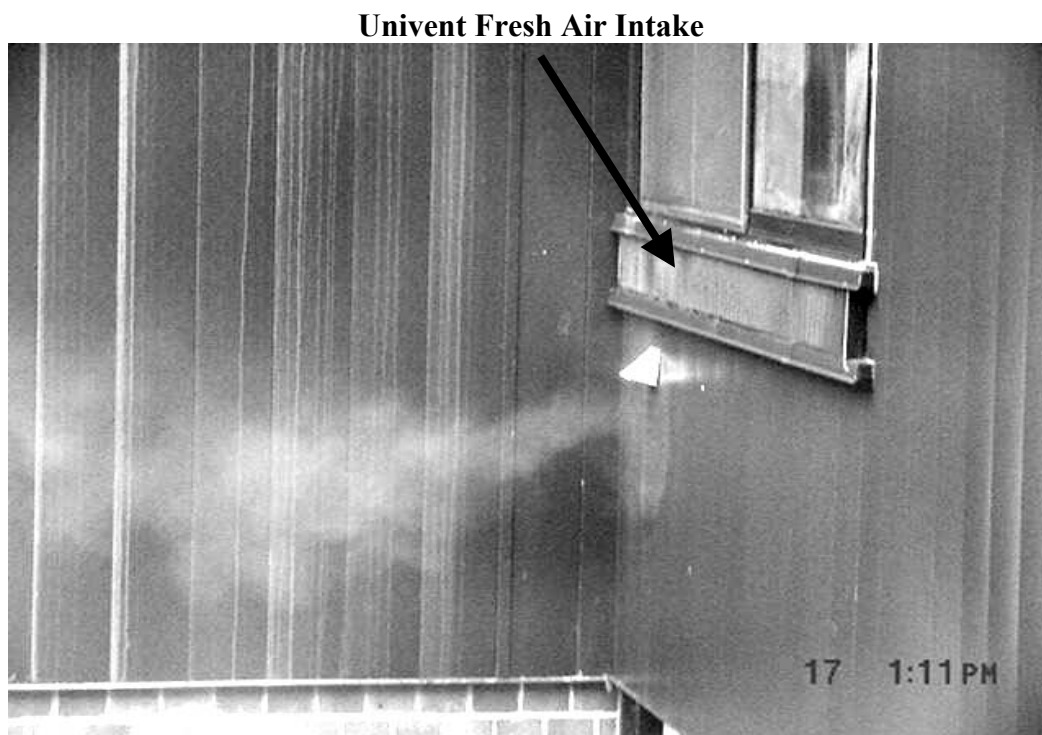
**Picture 28**

The dryer for the consumer science area is ducted out of the building below a univent air intake (see Picture 28). Although the vent empties downward away from the air intake, the possibility of re-entrainment of dryer exhaust is possible depending on certain wind and weather conditions.

**Dryer Exhaust Vent Below Univent Air Intake; Note Water Vapor and Particulate during Operation**

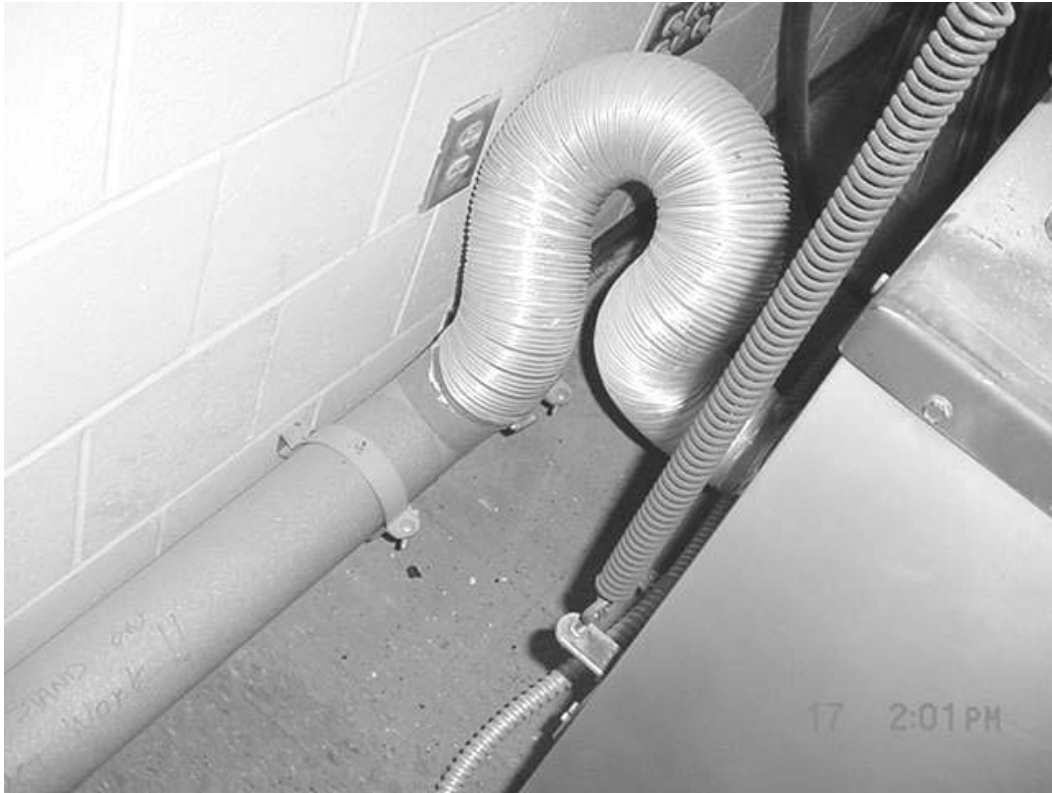
**Picture 29**

The art room contains two pottery kilns, which are also vented to the outside. Pottery kilns can produce carbon monoxide and sulfur dioxide, which can cause respiratory symptoms in exposed individuals. BEHA staff noted strong kiln odors in the general vicinity with the exhaust operating. The kilns are connected to the exhaust ductwork by flexible hoses. It appeared that the hoses were too long, each forming a hairpin turn before entering the ductwork (see Picture 29). Airflow is decreased roughly in half by every 90° angle that exists in ductwork. The ductwork contains over 180° of angles. If the draw of fresh air by the exhaust fan was 100 percent, the angles of this ductwork would reduce that draw to approximately 25 percent.

**Flexible Ductwork for Pottery Kiln**

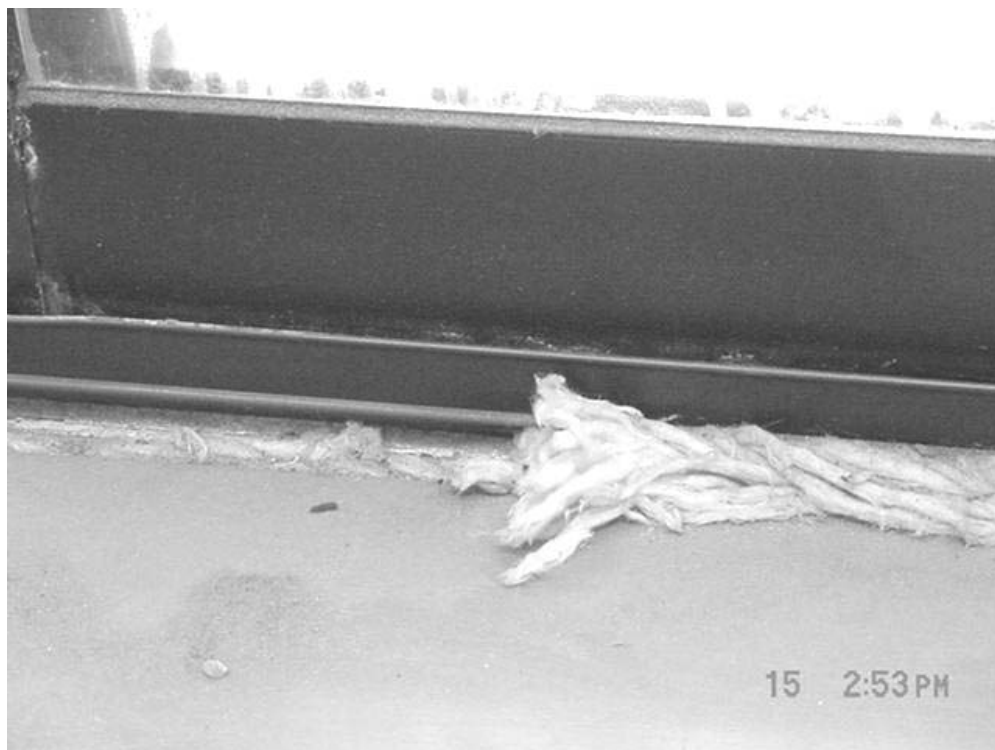
**Picture 30**

Exposed fiberglass insulation was observed around univents in a number of classrooms (see Picture 30). Fiberglass insulation can be a source of skin, eye and

**Exposed Fiberglass around Classroom Univent**

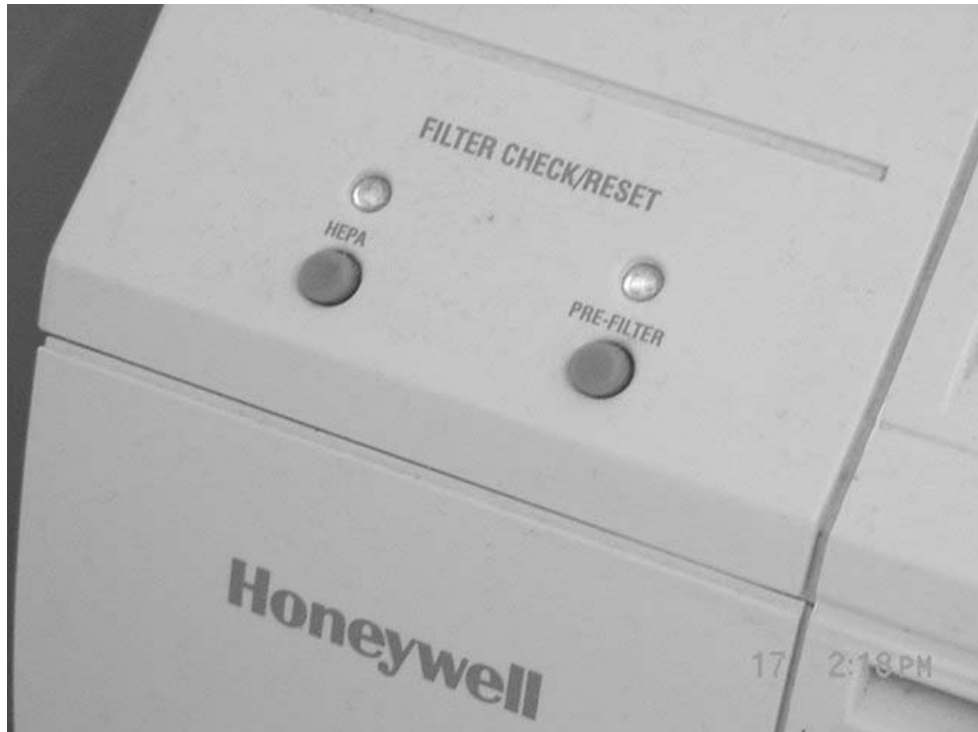
**Picture 31**

**Indicator Lights on Wall-Mounted AC Unit Indicating Filters Are Saturated**

28. Change filters for all air-handling equipment, air conditioning units and air purifiers as per the manufacturer's instructions or more frequently if needed. Vacuum interior of univents and AHUs prior to activation to prevent the aerosolization of dirt, dust and particulate. Ensure filters fit flush in their racks with no spaces in between allowing bypass of unfiltered air into the unit.

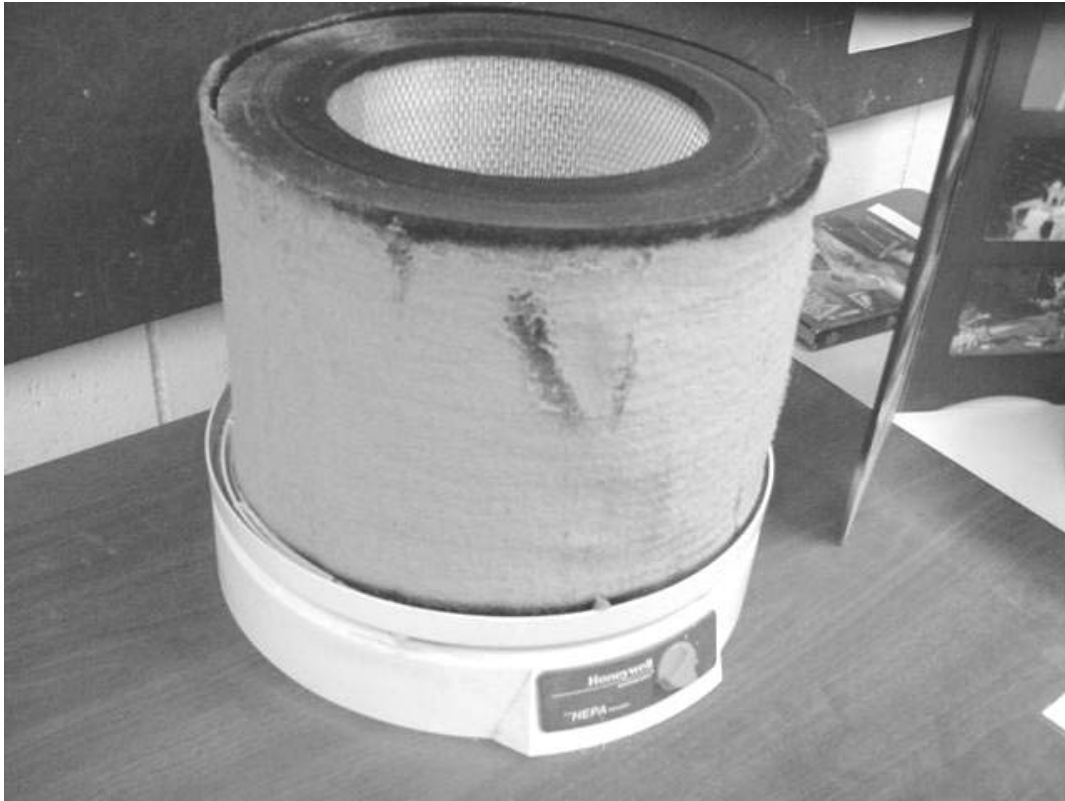
**Picture 32**

respiratory irritation to sensitive individuals. A number of areas had portable air purifiers and/or wall-mounted air conditioning units. BEHA staff inspected filters in a number of these units and found them coated with dirt/dust (see Pictures 31 & 32). Without cleaning/changing filters, the activation of these units can re-aerosolize dirt, dust and particulate, which can be irritating to certain individuals.

**Portable Air Purifier Occluded With Dust/Dirt**
